GEOTECHNICAL RECONNAISSANCE OF THE 2010 DARFIELD (NEW ZEALAND) EARTHQUAKE

Version 1: 10 November 2010

EDITORS

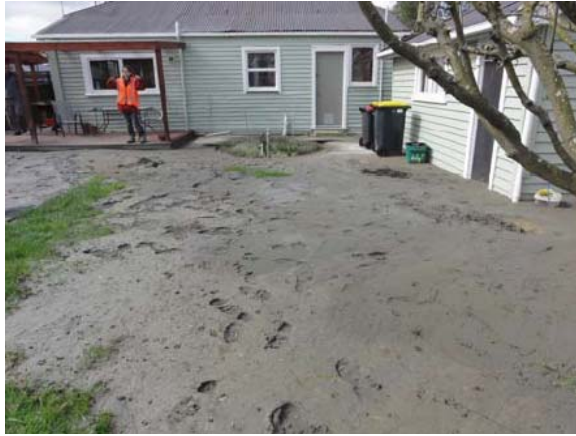
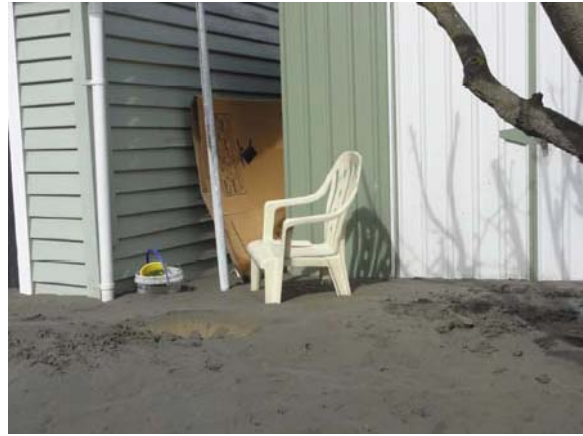
Typical manifestation of liquefaction in the backyard of a residential property is shown in Figure 4.4 (Bracken St, Avonside). Sand boil ejecta covered most of the lawn and was about 20 cm thick in places. There was evidence of massive liquefaction and large surface distortion on Bracken St. The potable water and sewer systems were out of service at the time of the inspections. Despite significant amounts of liquefaction ejecta and broken utilities throughout the neighbourhood, the house shown in the pictures suffered minor damage in terms of differential settlement and cracking.

(a) Massive sand boils in residential area of Avonside (Bracken St)

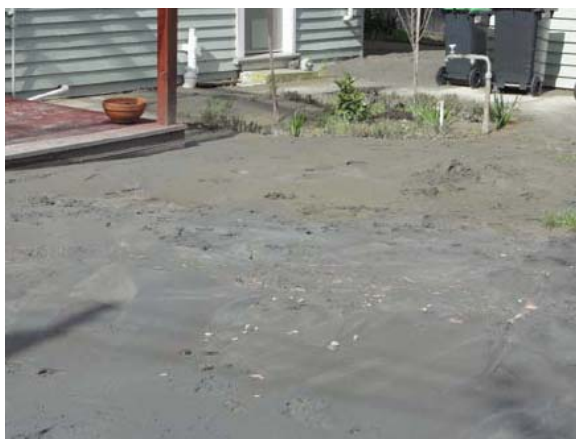
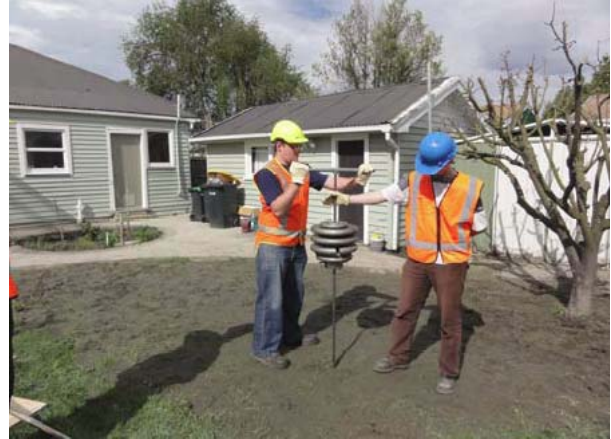
(b) The sand boil (grey non-plastic silty sand) in the bottom half of the photo to the left was typical of many locations across Christchurch and Kaiapoi where massive liquefaction was observed; at this location, a brown silty sand was also found on the ground surface (upper half of the sand boil); photo to the right: University of Canterbury postgraduate students perform Swedish Weight Sounding (SWS) test (Bracken St)

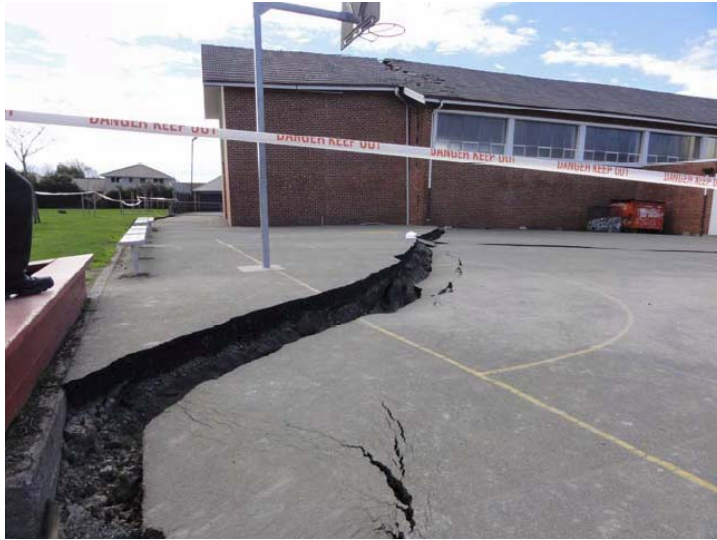
The geotechnical reconnaissance team performed a detailed survey at St Paul's Church (Gayhurst Rd, Dallington) which suffered damage due to liquefaction in the foundation soils (Chapter 5). Figure 4.5 shows a complex pattern of ground distortion including large cracks and vertical offsets around the building. Extensive sand boils covered the paved area around the building, backyard lawn, and around the perimeter of the building and its foundations. The building suffered large differential settlements and severe structural damage.

(a) Bearing failure in liquefied soils (St Paul's Church, Dallington); the crack is 50-90 cm wide with a vertical offset of 33 cm, at its maximum

Specifically, the northwest side of the building was ripped in half due to a combination of differential settlement and lateral movement. This site is centrally located in a meandering loop of the Avon River and bounded by the river on all sides at distances of about 150-250 m, except to the north/northeast. There was apparent evidence of lateral spreading in this area, despite being located more than 150 m from the free-face of the river. (Note, however, that this distance is not necessarily anomalous. Evidence of lateral spreading has been found at distances of up to 2 km from a free-face in the New Madrid, Missouri, USA, area (Obermeier, S.F., per. comm.). These features manifested during the 1811-1812 earthquakes that occurred in that region.) The tension cracks and fissures around the building were much bigger than those near the river channel, and hence it is possible that they are not directly related only to the lateral spreading. Further investigations are required to clarify these details.

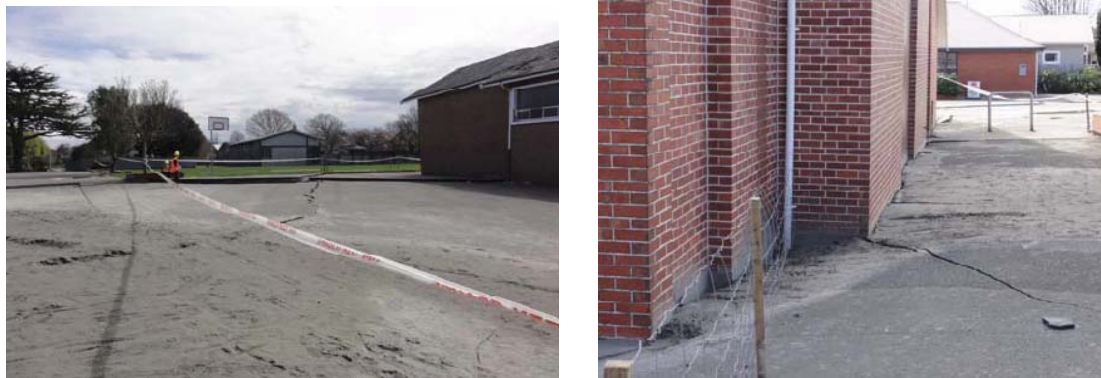
(b) Evidence of liquefaction in foundation soils resulting in large total and differential settlements

Figure 4.5 Liquefaction-induced bearing failure in Dallington (St Paul's Church, Gayhurst Rd)

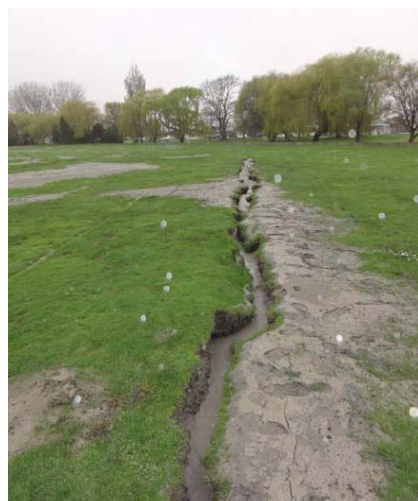
Further to the east of Dallington, extensive liquefaction, including substantial lateral spreading, was observed in Porritt Park (Wainoni), which is enclosed by the Avon River and a diverted stream around the park. Large sand boils covered substantial areas of the park (Figure 4.9). Parallel cracks spaced regularly along drainage lines were indicative of slumping and spreading towards the north and south branches of the stream. A couple of hockey fields located in the park were severely damaged by the liquefaction, resulting in a very uneven, bumpy surface of the fields.

(b) ~ 10 cm wide lateral spread crack

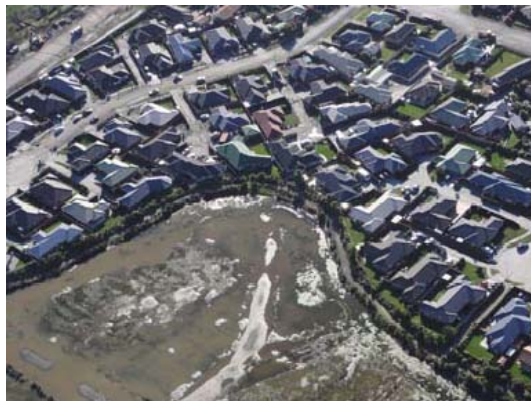
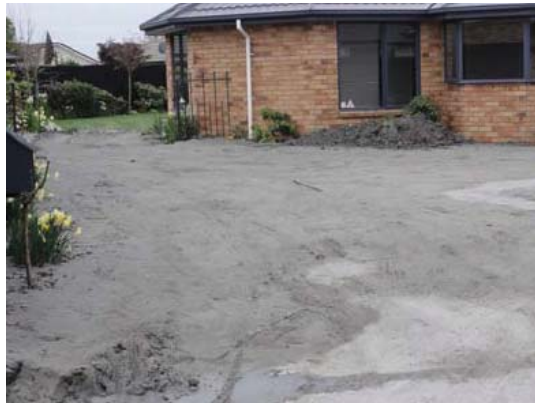
Widespread liquefaction occurred in Bexley, affecting a large number of residential houses (Figure 4.10). Ground distortion (i.e., differential settlement, large ground cracks, deformation of paved surfaces and substantial sand boils) was observed at Seabreeze St and Kokopu Ln. Residential properties along the southern edge of Bexley (along the wetland walkway) were severely affected by lateral spreading. Large movement of the walkway towards the water, slumping of the terrace fill and large ground cracks on residential properties were observed in this area. Similarly, severe manifestation of lateral spreading was observed at the east end of Bexley (Parenga Pl).

(a) Aerial view of the southern edge of Bexley which was severely affected by liquefaction and lateral spreading; (b) Evidence of liquefaction in residential area (Seabreeze St)

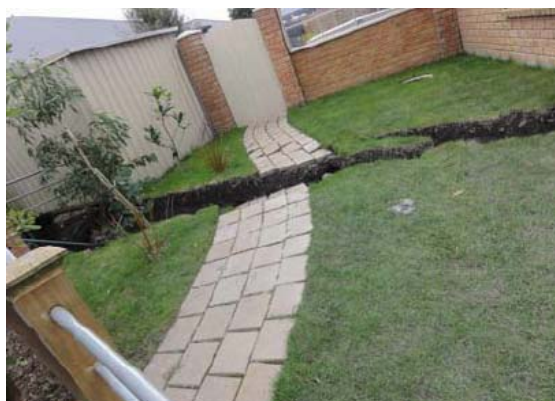
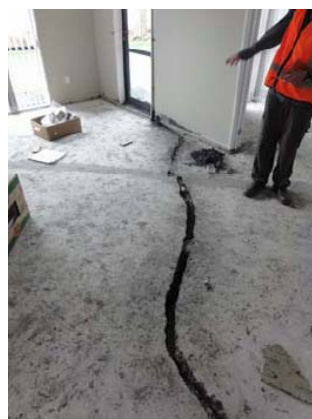
(c) Large ground cracks due to lateral spreading at Kokopu Pl; (d) Cracks in unreinforced slab induced by lateral spreading

Figure 4.10 Evidence of extensive liquefaction severely affecting residential houses in Bexley

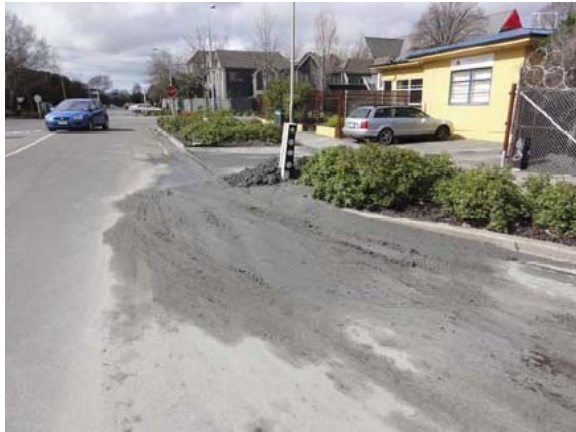
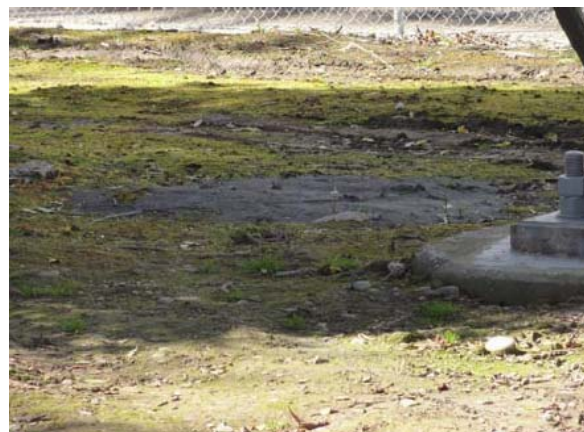
Limited or partial liquefaction was observed at numerous locations across the city, which manifested as scattered and relatively small (or within limited area) sand boils. In these places there was damage to roads, footpaths, and driveways as well as some house damage, but the liquefaction effects were moderate or mild. Figure 4.12 shows typical manifestation of limited liquefaction in CBD (Peterborough St) and in the backyard of a power sub-station

(a) Evidence of liquefaction at Peterborough St - Madras St (CBD) ; (b) Sand boil in the foundation soils of a transmission tower (sub-station northeast of Greers Rd – Ruddenklau Ln, Bishopdale) (43.4928055°S, 172.5918055°E)

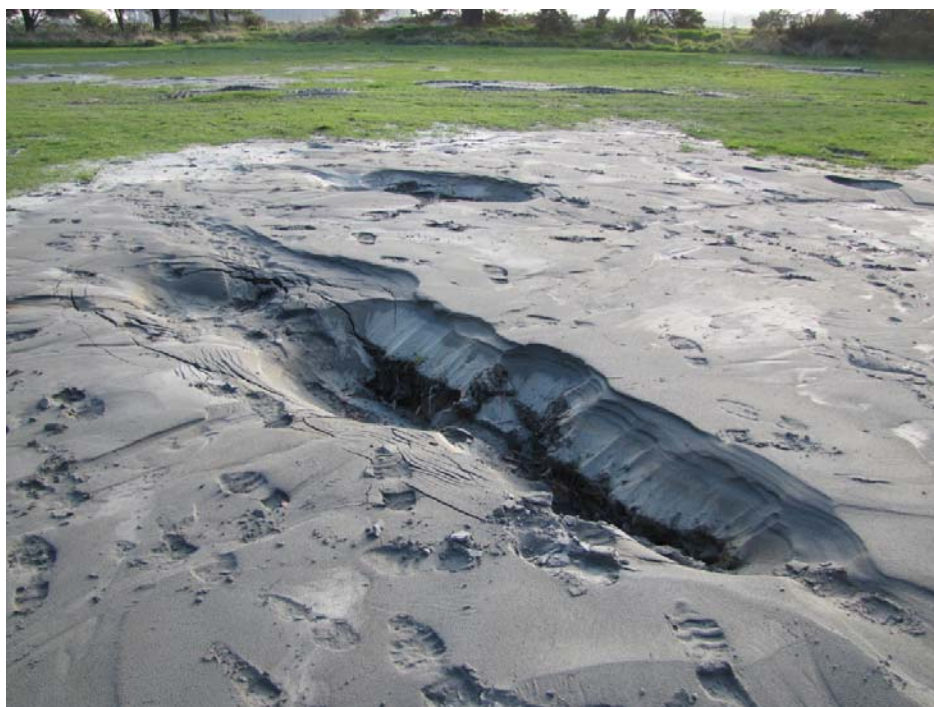
Figure 4.14 Sandboil in the Featherstone Reserve Pines Beach from which sand was taken for electron microscope pictures

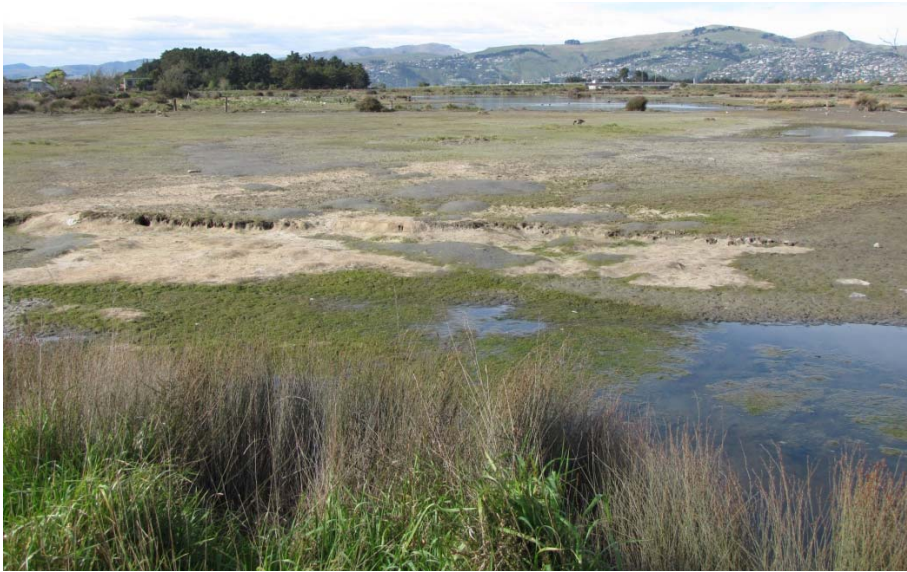
Residents of the Bexley area commented on the effect of the earthquake on the Bexley Wetlands. Figure 4.19 shows a view from walking path around the south of the subdivision. Many sand boils are seen in the bed of the wetland area (at high tide on 29 September) which was inundated at high tide prior to the earthquake.

Figure 4.19 View of the Bexley Wetland at near high tide on Wednesday 29 September 2010. Prior to the earthquake this area was inundated at high tide.

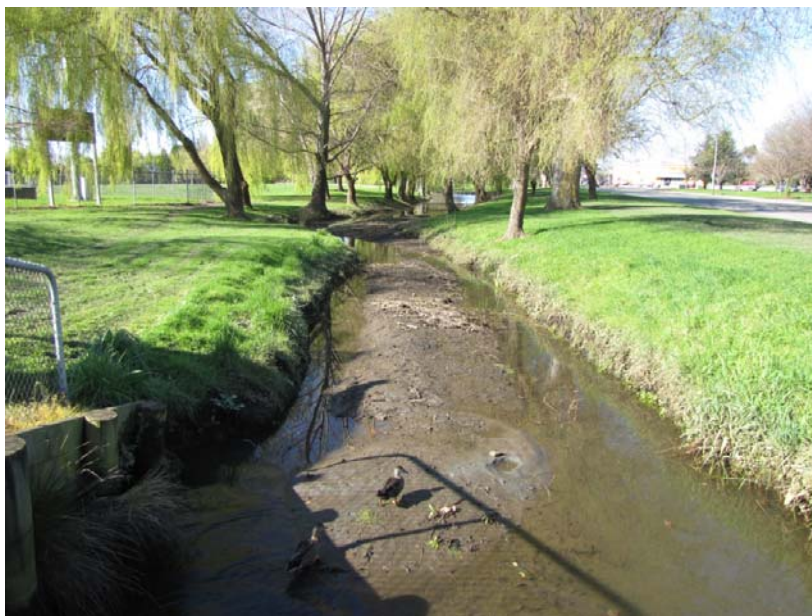
Stream beds were also noticed to be heaved (Figure 4.20). A local resident confirmed that this was not how the stream bed appeared prior to the earthquake. In some places it was necessary to clear the stream bed soon after the earthquake.

Figure 4.20 Photograph of the stream near Porritt Park on Wednesday, 15 September 2010. There is lateral spreading towards this stream from both sides. It is just possible to make out a sand boil in the midst of the stream bed debris to the right of the duck. Several other sand boils were visible along the stretch of heaved stream bed.

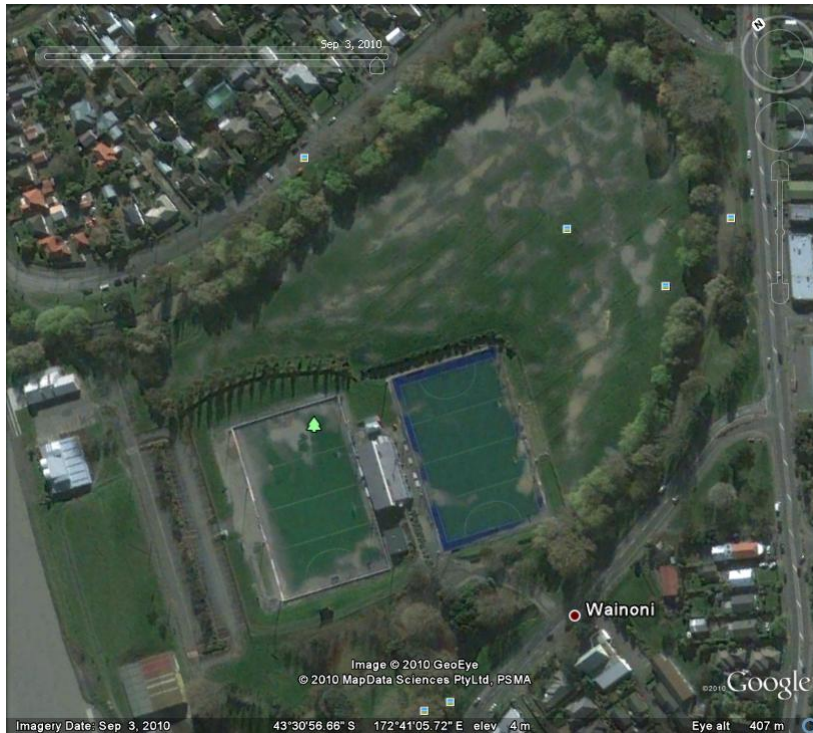
A few hours after the earthquake, a GeoEye image of part of the area affected by the earthquake was captured. Since Saturday September 04 was a clear day, this image provided good evidence of liquefaction in some parts of the city. Figure 4.21 shows part of the GeoEye image covering Porritt Park (location about 43.515555°S, 172.685277°E; the image date is 3 September 2010 because GMT, rather than the local time and date in Christchurch, is used by Google). Figure 4.9a shows a picture of Porritt Park taken from a helicopter on the afternoon of Friday, 10 September 2010.

Figure 4.21 Image of Porritt Park extracted from the GeoEye image taken a few hours after the earthquake (Google Inc., 2010)

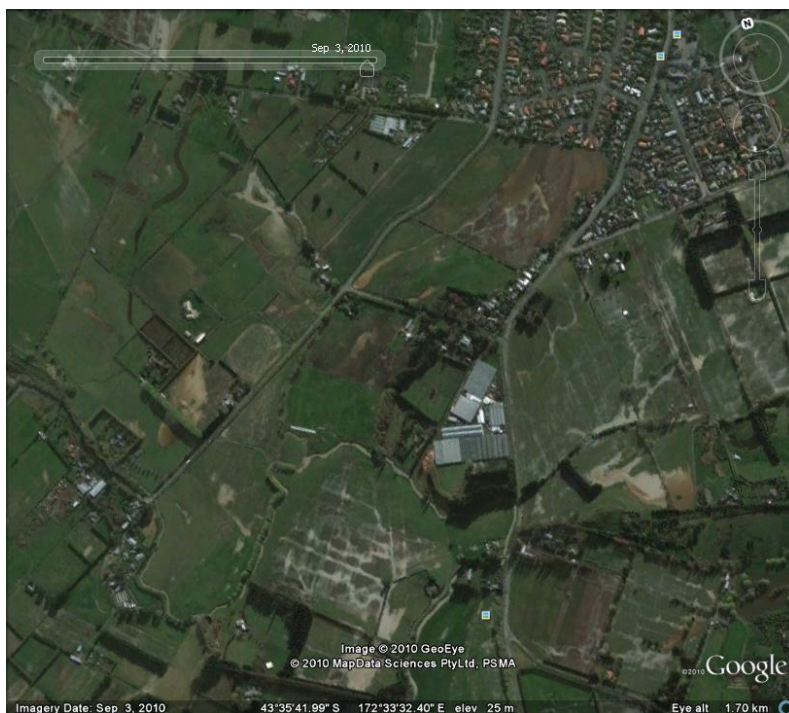
Figure 4.22 Part of Halswell as imaged by GeoEye after the earthquake. The ejected sand is accompanied by considerable volumes of water forming mini-lakes having a similar colour to the ejected sand (Google Inc., 2010)

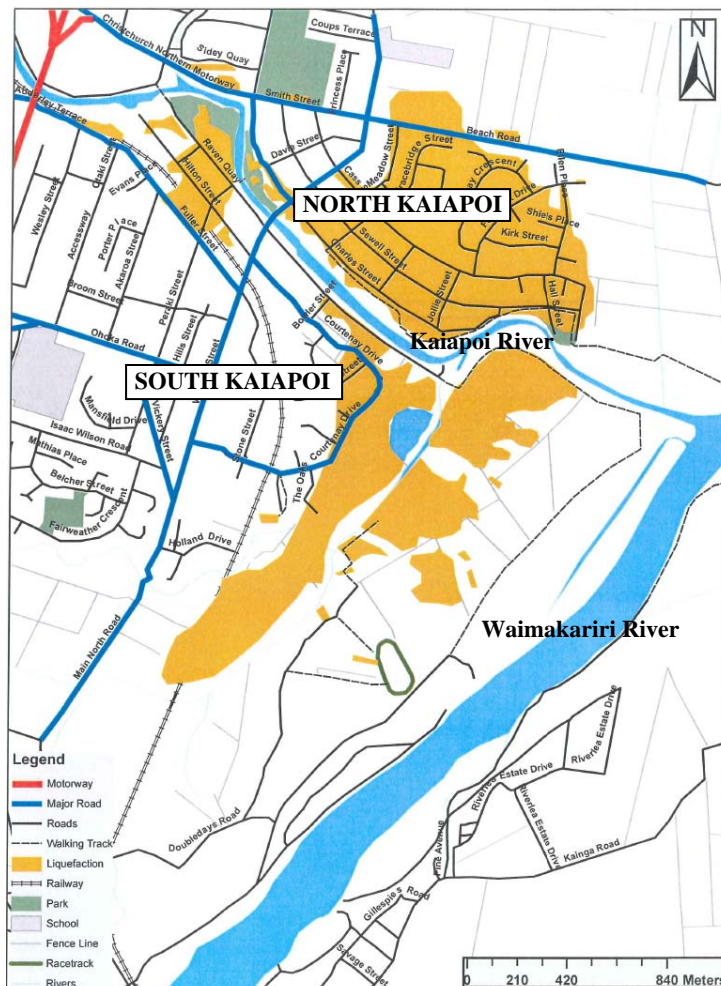
In the 2010 Darfield Earthquake, widespread liquefaction occurred north of the Kaiapoi River (Charles St, Sewell St, Cassia St) affecting a large number of residential houses. The houses in this area are typically single- or two-storey brick/stone block masonry or timber structures on spread footings. Figure 4.24 shows areas of severe and moderate-to-low liquefaction in the town of Kaiapoi. A strong motion station located in north Kaiapoi recorded a PGA of approximately 0.32g (geometric mean of the horizontal components) during the earthquake.

Figure 4.24 Areas of observed liquefaction in the town of Kaiapoi due to the 2010 Darfield earthquake (the liquefaction map is based on surface manifestation of liquefaction visible on aerial photographs and compiled evidence from ground surveying)

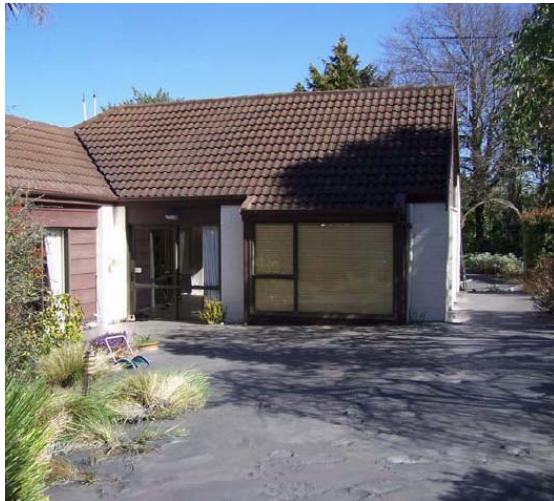
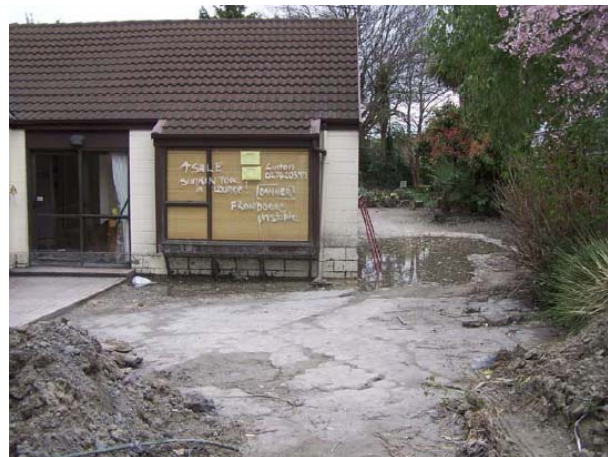
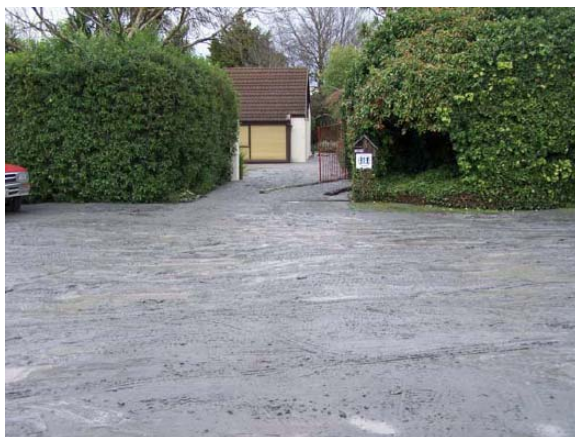
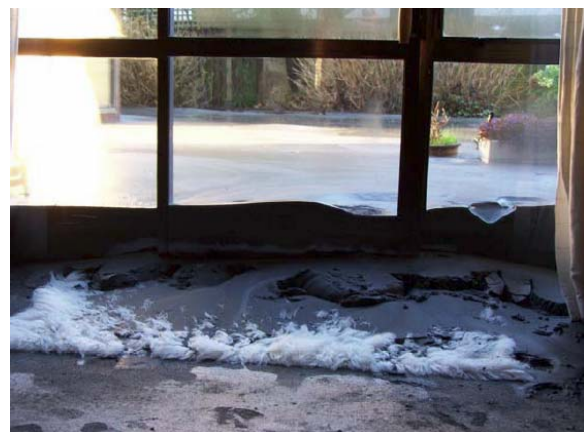
The liquefaction was particularly intense, producing massive sand boils of grey, silty sand, at Cassia Place and at the east end of Charles and Sewell streets. In the worst hit area, the silty sand ejecta was about 400 mm thick, as shown in Figure 4.25. Some residents reported geysers appearing in the backyard following the earthquake, often forming a small pond near the house that remained for several days after the event. An SWS test and DPTs were performed by the team in this area, with the SWS test indicating loose/soft soils up to depths of 8-9 m (Figure 4.26).

(a) ~40 cm thick layer of silt-sand-water mixture covering a residential property affected by very severe liquefaction; (b) same-angle view, but after the clean up of sand boils

(c) View from the street (before clean up); (d) liquefied silt-sand-water mixture covering the ground outside the house and a rug inside the house (seen through a window from inside the house)

Figure 4.25 Manifestation of very severe liquefaction in residential area at Cass Pl, North Kaiapoi

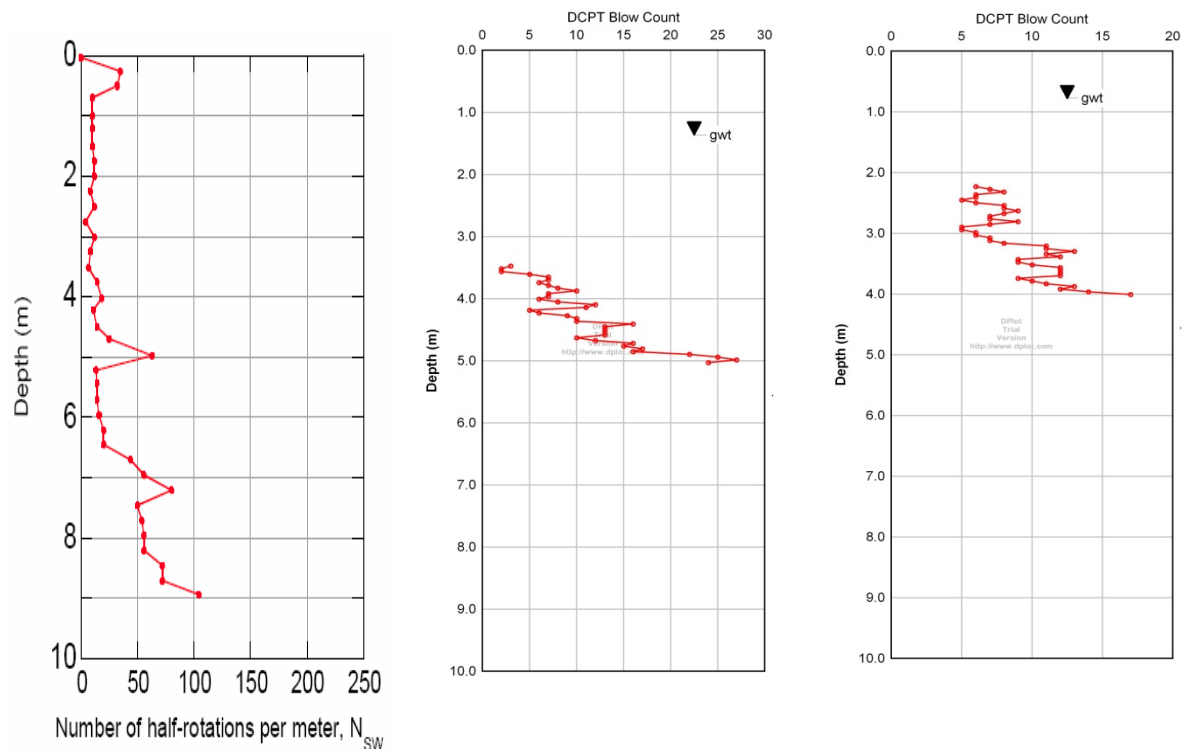
Figure 4.26 Results of SWS test and DCPTs performed in the backyard of a house at Cassia Pl.

As determined from the bore holes augered for the DCPTs, the depth to the ground water table and to the top of the liquefied layer differed between the two test locations at Cassia Pl although the test locations were only ~25 m apart. However, the surface elevation of the two test locations differed by about 0.5 m. As a result, the elevations of the ground water table are similar for the two test locations, with the depth to the top of the liquefied layer differing slightly. As with the site on Bracken St (Figure 4.4), a 10- to 15-cm thick, very wet, very soft clay/plastic silt layer overlies the liquefied layer.

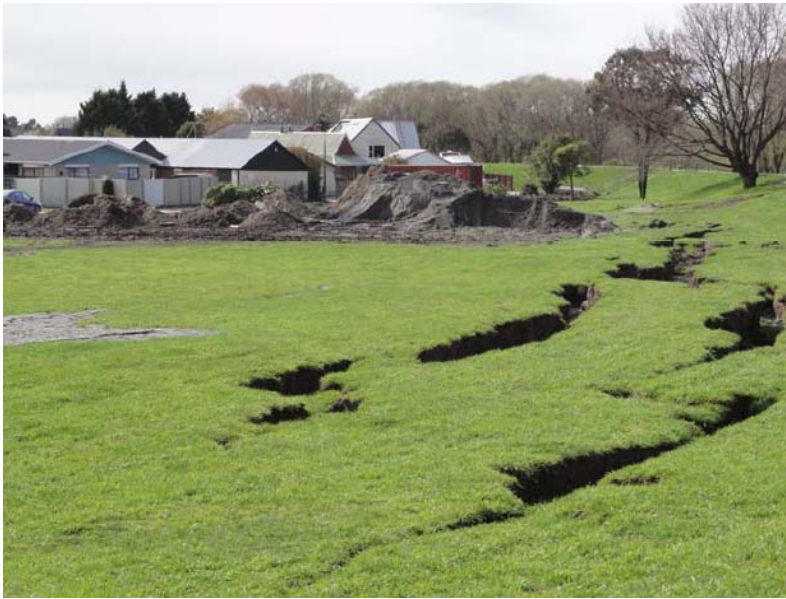
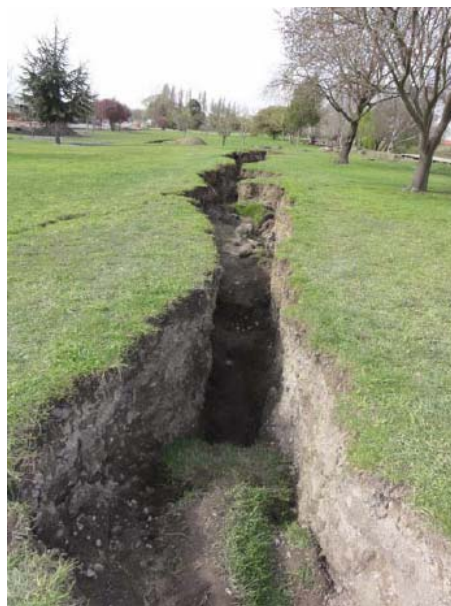
The area along the Pegasus Bay Walkway (from the Kaiapoi Visitor Information Centre on the east to Askeaton Park on the west) was affected by significant lateral spreading with large cracks and fissures in the sloping ground towards Charles St (Figure 4.27). Residential houses in this area were affected both by liquefaction and lateral spreading (Figure 4.28). The reconnaissance team carried out detailed ground surveys of lateral spreading along several profiles at this location which will be presented in further more detailed publications. In addition two bore holes were made using a hand auger. However, the profile largely consisted of random fill (gravels/cobbles and wood), making it difficult to advance the auger. One of

the bore holes went down to a depth of ~5.5 m, yet a thick liquefied layer could not be found. However, thin (< 10 cm) alternating layers of loose saturated sand and very wet, very soft clay/plastic silt were encountered, particularly near a large lateral spread crack (Figure 4.27b). This lateral spread crack had no traces of ejecta in and/or immediately near it. This crack was closer to the river than ones that were filled with ejecta, which were an additional 30 m further from the river. It is possible, that the overlying soil layers slid on these alternating layers of loose sand and clay/plastic silt that likely liquefied/softened during the earthquake shaking.

(a) Lateral spread and slumping of the north stopbank of the Kaiapoi River near the east end of Charles St; note the huge piles of cleaned up sand obstructing the view of the houses

(b) Lateral spreading of the north stopbank of Kaiapoi River (Charles St – Jones St)

Figure 4.27 Evidence of liquefaction and lateral spreading along Charles St and the north stopbank of the Kaiapoi River (43.384694°S, 172.660944°E)

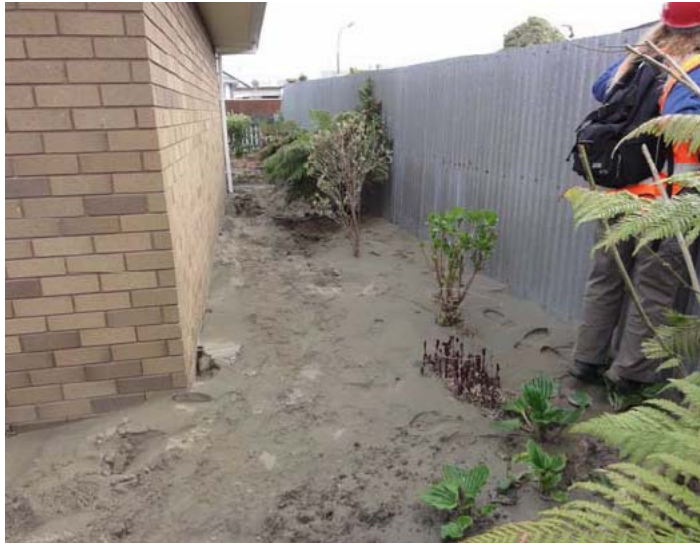
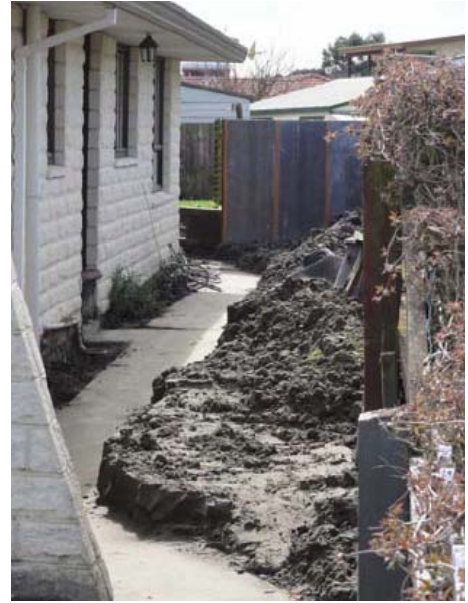
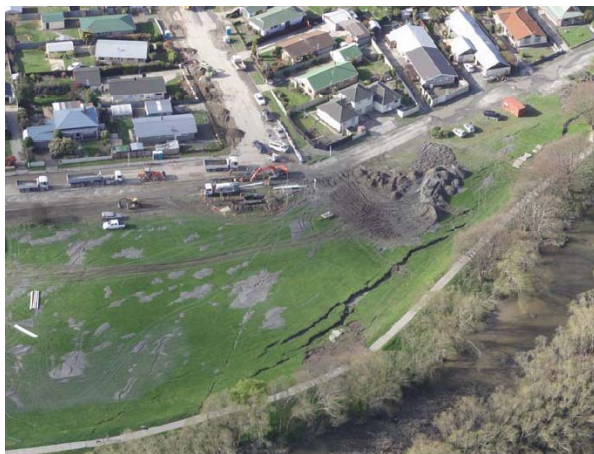
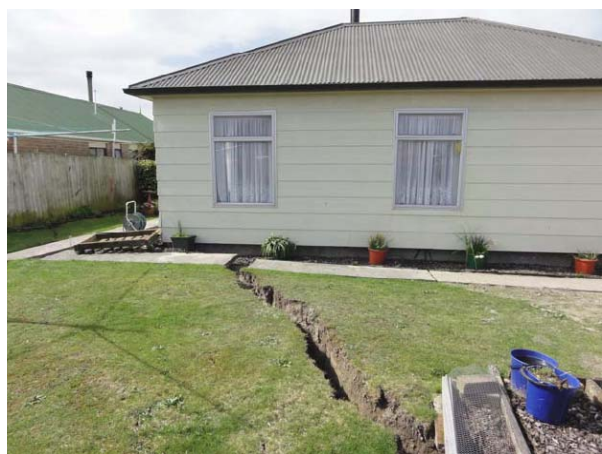
In this general area, including near the east end of Charles St and Sewell St, the liquefaction led to large settlement of many houses, including differential settlement that resulted in structural damage. The large ground distortion, cracks and fissures in the ground caused significant damage to buried lifelines in this area. The intensity of liquefaction gradually decreased from severe to moderate-to-mild and no liquefaction when moving away to the north or west from the Beswick St-Cass St-Askeaton Dr block.

(a) Evidence of extensive liquefaction at the east end of Charles St

(b) Lateral spreading resulting in a large ground distortion in foundation soils (Charles St)

Figure 4.28 Liquefaction and lateral spreading in North Kaiapoi

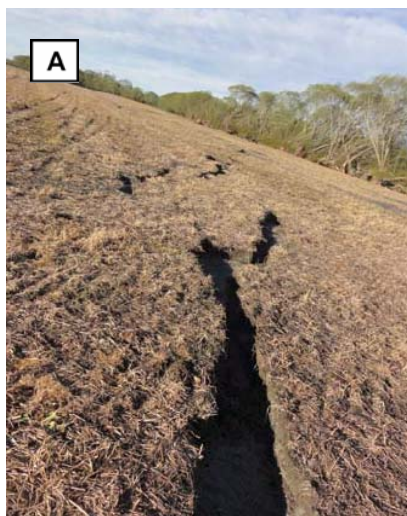
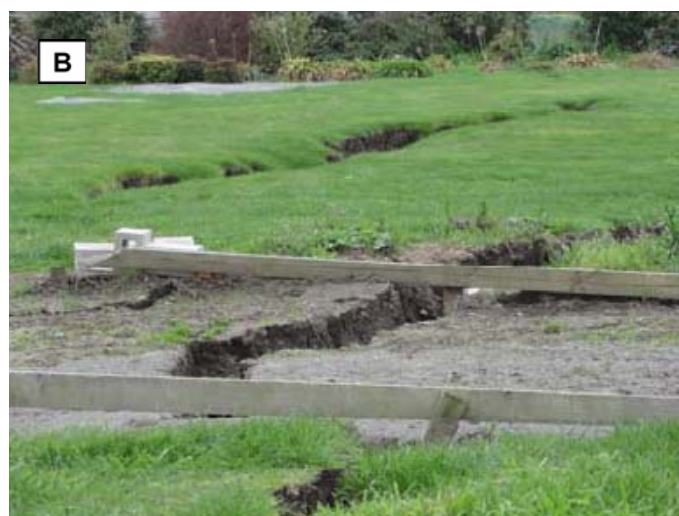
In South Kaiapoi, the most dominant ground failure feature was the liquefaction and massive lateral spreading that affected the eastern branch of Courtenay Drive. The area affected by lateral spreading, shown in Figure 4.29, was approximately 1-km long in the north-south direction and extended between 200 m and 300 m inland from the Courtenay Stream and Courtenay Lake. The lake was artificially created during the construction of the northern end of Courtenay Dr. Borrow material was removed from the area where the lake is presently located and used as hydraulic fill (about 1 m thick) for the northern branch of Courtenay Dr (WDC, 2010).

(b) Large lateral spread cracks in farm land

Figure 4.29 Massive lateral spreading at South Kaiapoi

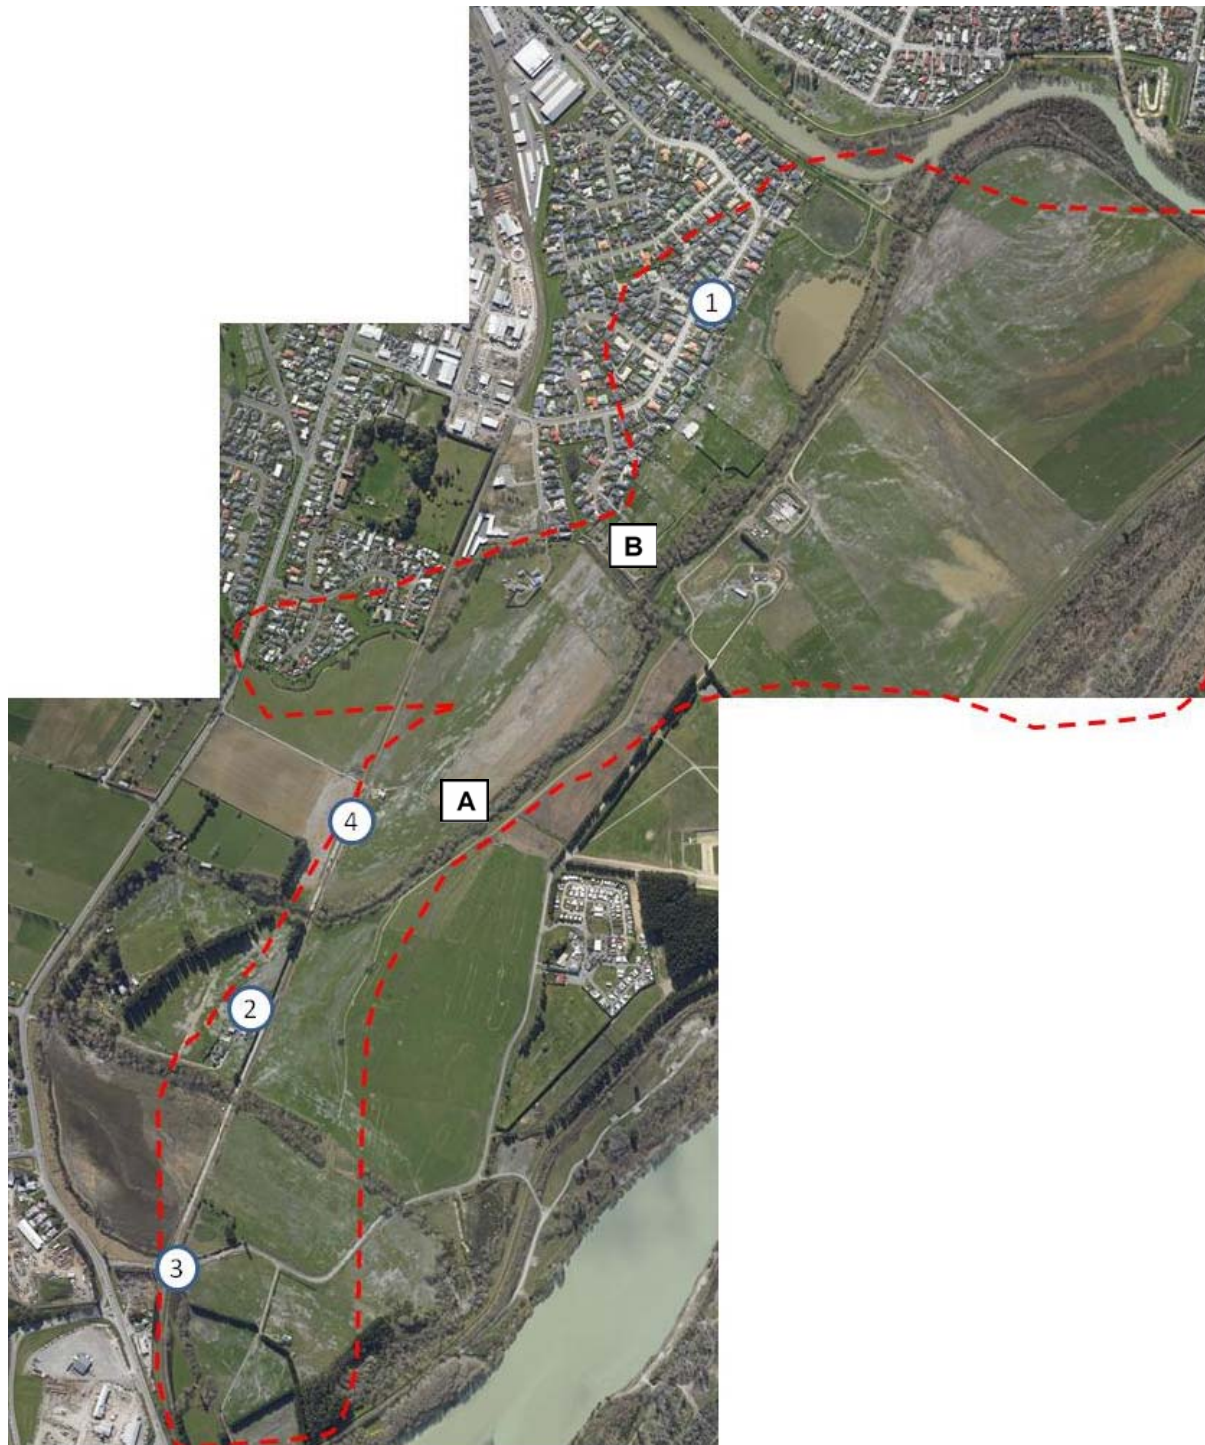
The eastern edge of Kaiapoi is shown in aerial photographs taken after the Darfield earthquake (Figure 4.30). The outline of the 1865 Waimakariri river channel (Figure 2.9) is shown by the dashed red line. On the eastern side of Kaiapoi, the old channel passes underneath the present day Courtenay Dr area shown as position 1, where severe damage to residential properties occurred due to lateral spreading (Figure 4.34). Further south at positions A and B (Figure 4.29), large cracks due to lateral spreading towards Courtenay

Figure 4.30 Aerial view of the lateral spreading area at South Kaiapoi

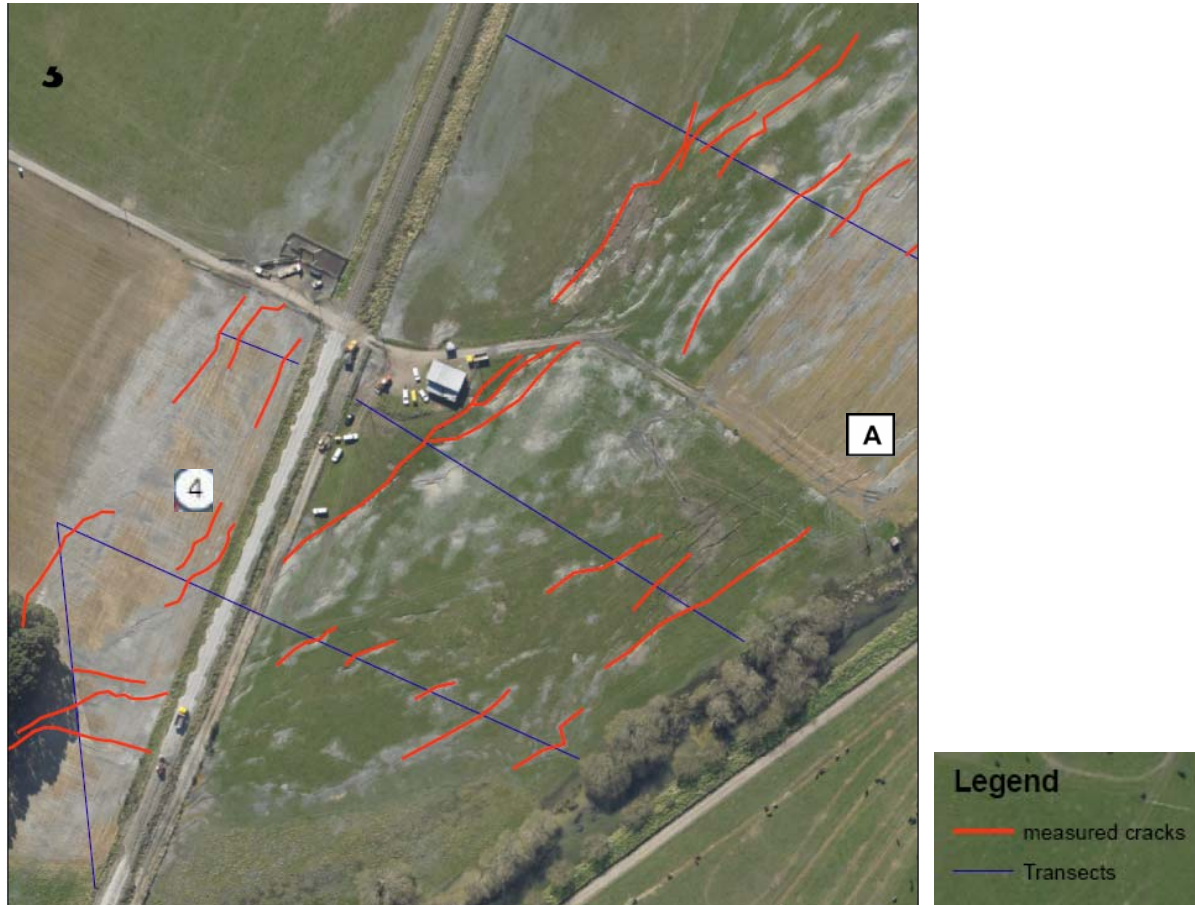
Stream are evident. Along this stretch from position A to the north-east corner of Courtenay Dr (slightly north of position 1), detailed ground surveys were conducted along ten transects including measurement and mapping of width of cracks, vertical offsets, and geo-tagging of major cracks and other lateral spreading features. Figure 4.31 indicates geo-tagged major cracks and four transects of detailed measurements at position A.

Figure 4.31 Aerial view of the lateral spreading area at position A at South Kaiapoi showing four transects of detailed ground surveys

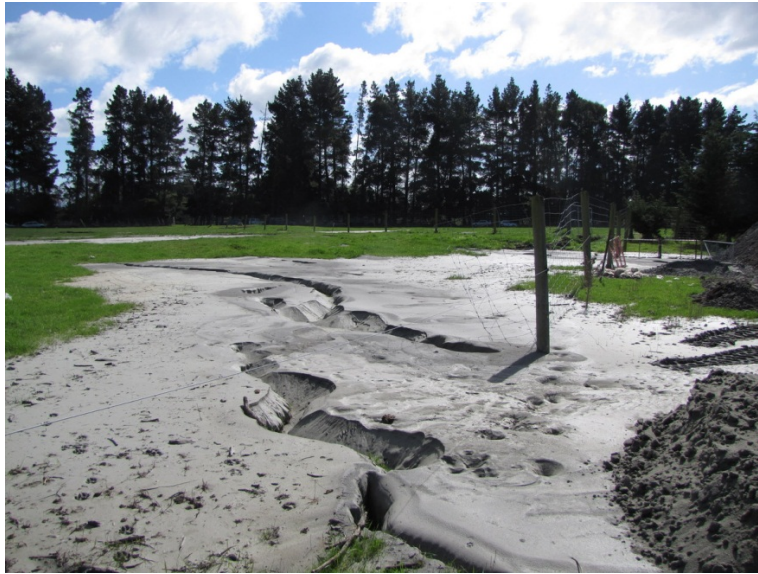
Further south near the train tracks at position 2 (Figure 4.30), large sand boils formed (Figure 4.32). At position 3 (Figure 4.33), liquefaction resulted in damage to the train tracks. The photo in Figure 4.33 was taken from a position on Doubleday's Rd in a NNE direction along the tracks, indicating ground deformation and track movement. Moving north along the train tracks to positions 4 and A (Figure 4.30), Figure 4.31 provides a more detailed aerial view of liquefaction and lateral spreading crossing the tracks just south of Kaiapoi. Using the vehicles in the photo for scale gives a good indication of the significant size of these cracks and the volume of ejecta.

Figure 4.32 Sand boils in fields (position 2; 43.4026°S, 172.6503°E)

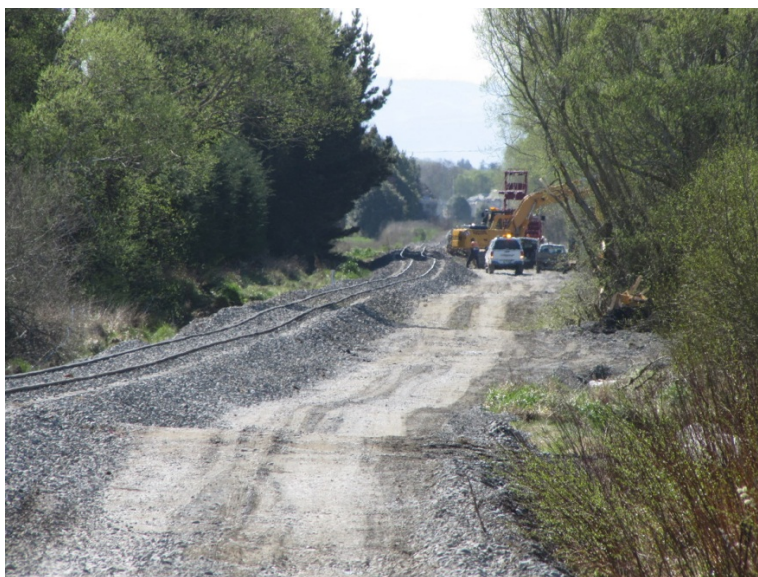
Figure 4.33 Damage to train tracks due to ground movement (position 3; 43.4068°S, 172.6489°E)

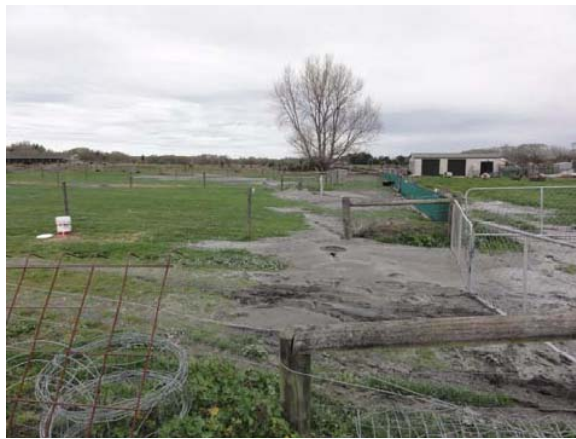
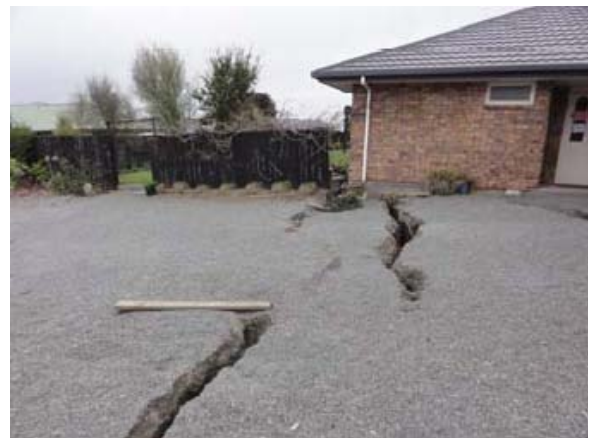
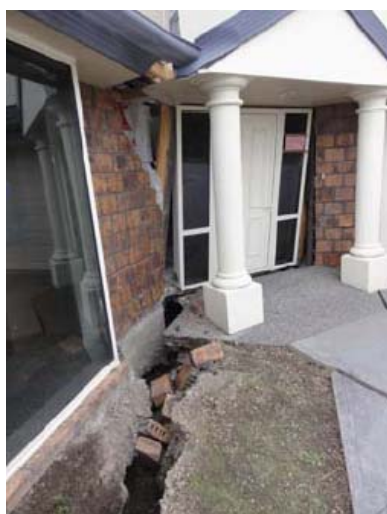
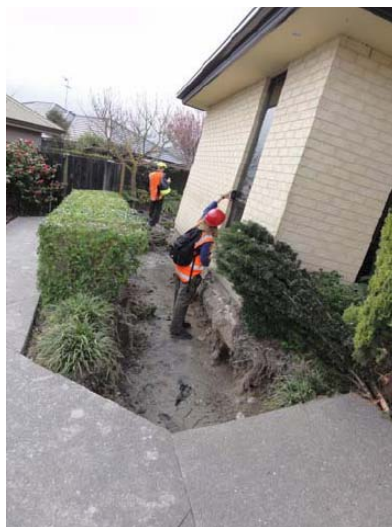
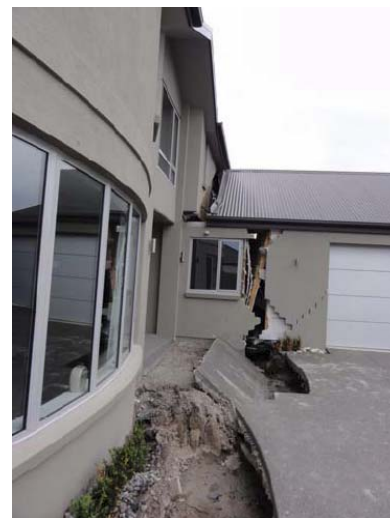
Lateral spreading resulted in large permanent lateral displacements on the order of 1.0-3.5 m with large ground cracks of about 0.5-1.5 m wide running through residential properties and houses along the east branch of Courtenay Dr. In this area, single storey and two storey houses suffered very severe damage due to large lateral ground movements including large tilt, loss of foundation support, tension cracks in foundations and slabs (Figure 4.34). It was significant that despite the extreme lateral movement of the immediate foundation soils and the foundations themselves, all houses showed large ductile deformation capacity and continued to carry gravity loads, despite literally being ripped in half in some cases. The

reconnaissance team visited the area and conducted detailed inspections and measurements of the distorted houses on several occasions. There was clear evidence that the lateral movement, at least in some parts of the affected area, continued to develop/increase well after the main event. Two consecutive measurements of the width of a large ground crack carried out on 11 and 15 September showed an increase in width of 20 cm over this period (i.e. from 1.4 m to 1.6 m). The residents of the neighbouring property reported new extensive cracks appearing in their house over the same time period. It is believed that this continued deformation was the result of a combination of creep due to static driving shear stresses, significantly softened soils and effects of aftershocks on a structure marginally stable under gravity loads.

(a) Sand boils and lateral spread cracks

(b) Effects of lateral spreading in residential area

Figure 4.34 Lateral spreading at Courtenay Dr, South Kaiapoi

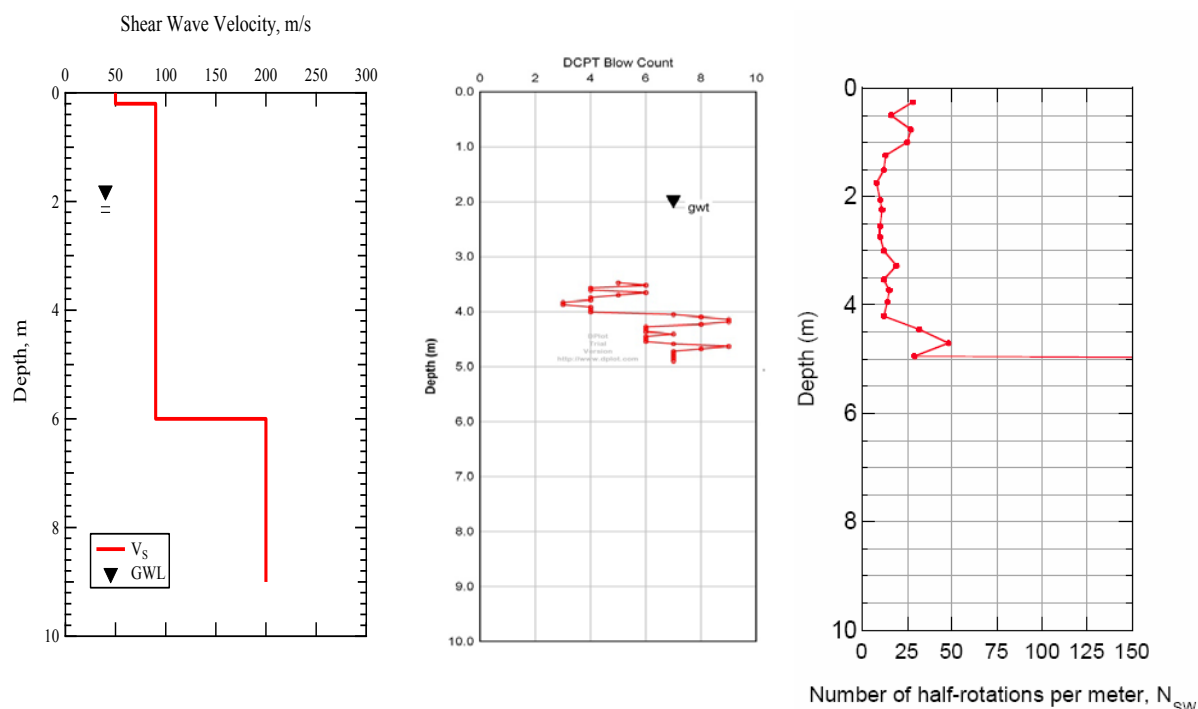
An SASW test, DCPT and SWS test were performed at a home along Courtenay Dr. The results are presented in Figure 4.35.

Figure 4.35 Results of SAWS test, DCPT and SWS test performed at a residential property along Courtenay Dr.

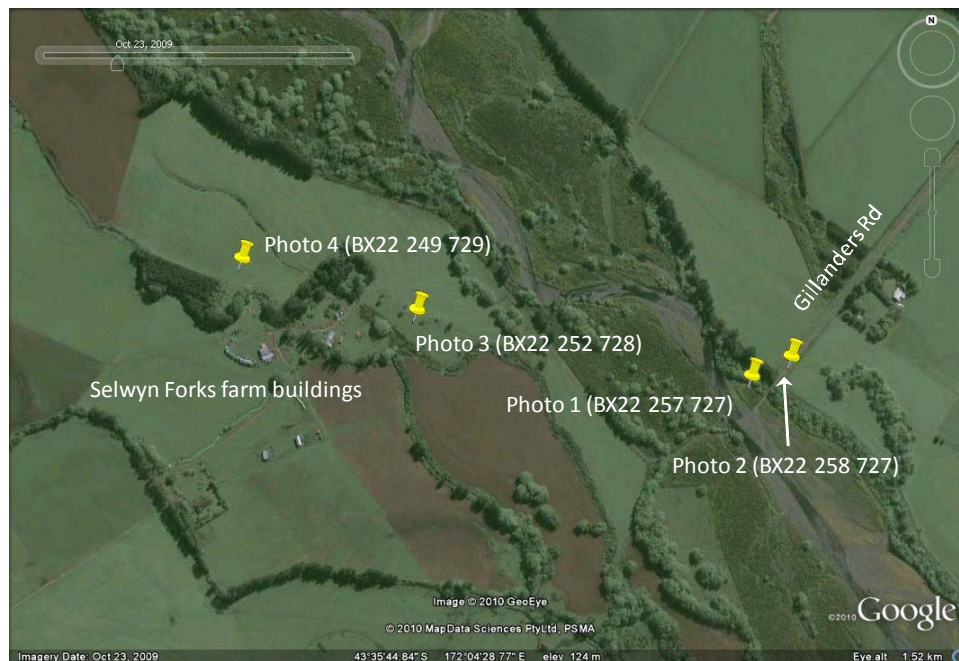
At the evening meeting of Sunday, 12 September, Pilar Villamor of GNS reported to the team that she had seen liquefaction in a farm paddock at the Greendale end of the fault trace. The paddock was on the Selwyn Forks property which is accessed from the Hororata - Dunsandel Rd on the southern side of the Hororata and Selwyn rivers. The locations of the liquefaction are shown in Figure 4.36.

Figure 4.36 Location of the liquefaction along the Selwyn River in the Greendale region. (Date of Google image October 23, 2009)
